Inspection Report
Minerals Regulatory Program
Report Date: October 26, 2006

Mine Name: Anval 1 & 2

Permit number: S010038

Inspection Date: October 16,
2006

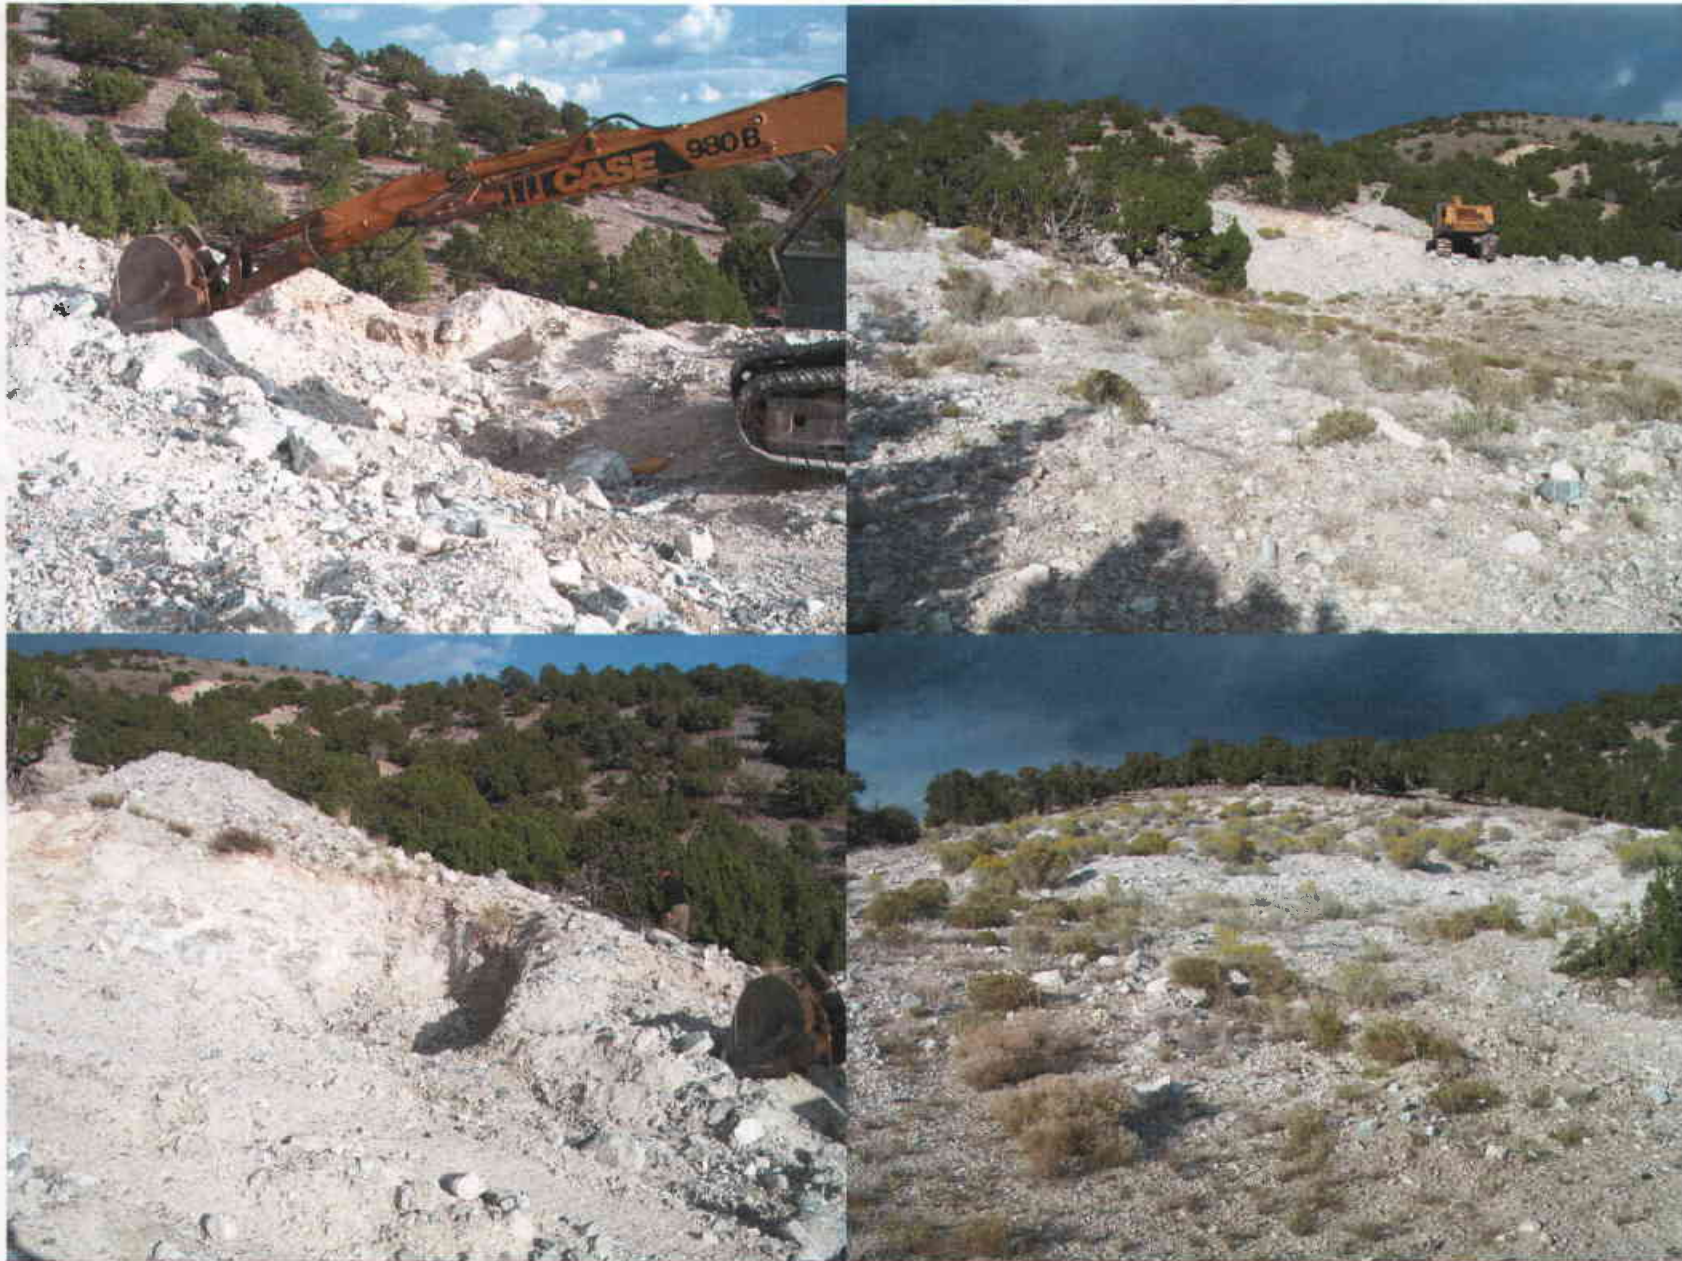
Anval 1&2 mine, S/001/038, October 16, 2006

1. The permit fee was paid on August 24, 2006.
6. A portion of this site has been reclaimed and the vegetation is coming in. Dan's GPS data show that .53 acres has been released.
7. There is a track hoe on site and some evidence of recent excavation although no activity was occurring at the time of the inspection. Dan Smith GPS'd the area of disturbance and identified .37 acres being utilized. Pictures were taken of the disturbed area and they show the extent of the disturbance. The pit is fairly shallow and I saw no concern with deleterious materials or safety hazards.

Should continue to monitor the site when in the area. The reclamation bond needs to have the Division named as a beneficiary.
